**Test Certificate**

Order dated : 4<sup>th</sup> November 2011  
Order : Testing of clay roof tiles in accordance with  
DIN EN 1304 by an independent, notified body  
Frost resistance in accordance with  
DIN EN 539-2:2006, Test method E  
(European single test method) and  
DIN EN 539-2 Correction 1:2009  
Number, type and color of samples : 6 interlocking tiles " Mediterranean"  
color natural red  
Manufacturer of samples : KE.B.E SA - Nea Santa  
Country of manufacture : Greece  
Date of Manufacture : Not specified  
Plant code : See 1.2  
Receipt of sample : 16<sup>th</sup> May 2012  
Test time period / date : 1<sup>th</sup> June - 26<sup>th</sup> June 2012  
Testing authority : Kiwa MPA Bautest GmbH, Munich Lab  
Test execution : Mr. Beyer  
Sampling : KE.B.E SA  
Sampling point : Not specified

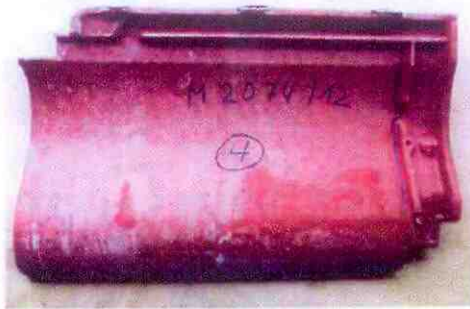
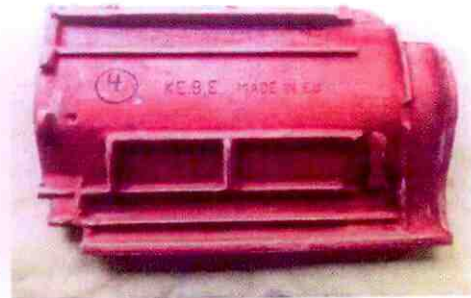
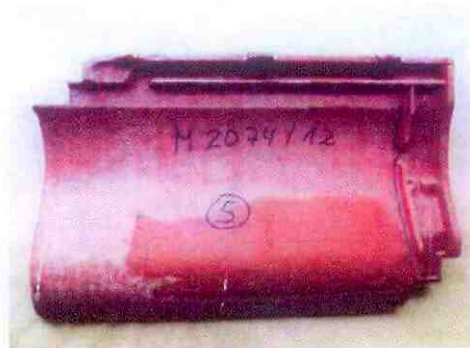
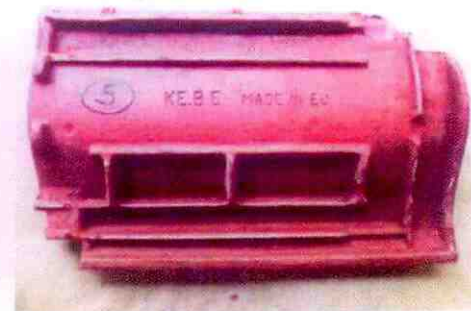
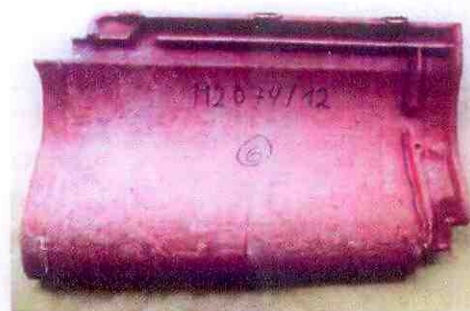
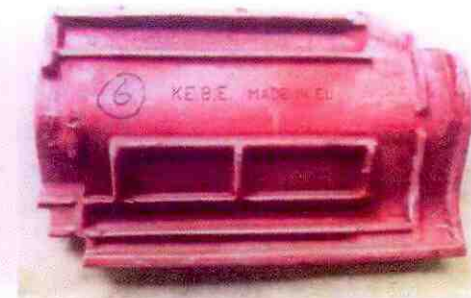
In accordance with DIN EN 539-2, Point 9.4.2.4 the back sides of the samples were covered with a wet linen cloth after which they were subjected to 150 freeze/thaw cycles at an average ice formation period of 40 minutes.

Sample no.	Number of executed freeze/thaw cycles	Nature and extent of changes caused by the effects of the freeze to		
		30 freeze/thaw cycles performance class 1	90 freeze/thaw cycles performance class 2	150 freeze/thaw cycles performance class 3
1	150	no	no	breaking-off of one nib, breaking-off of rib (back side acceptable frost damage)
2	150	no	no	breaking-off of one nib, (back side acceptable frost damage)
3	150	no	no	breaking-off of one nib, (back side acceptable frost damage)
4	150	no	no	breaking-off of rib (back side acceptable frost damage)
5	150	no	no	incipient chipping of rib (back side acceptable frost damage)
6	150	no	no	breaking-off of one nib, (back side acceptable frost damage)
Requirement satisfied		yes	yes	yes

The tested clay roof tiles are in compliance with the frost resistance according to DIN EN 539-2:2006 performance class 3.
